**SUSQUEHANNA RIVER BASIN
POLE RUN CREEK
SCHUYLKILL COUNTY**

**PENNSYLVANIA
NDS ID PA. 00686
DER ID 54-36**

POLE RUN DAM NO. 4

PHASE I INSPECTION REPORT NATIONAL DAM INSPECTION PROGRAM

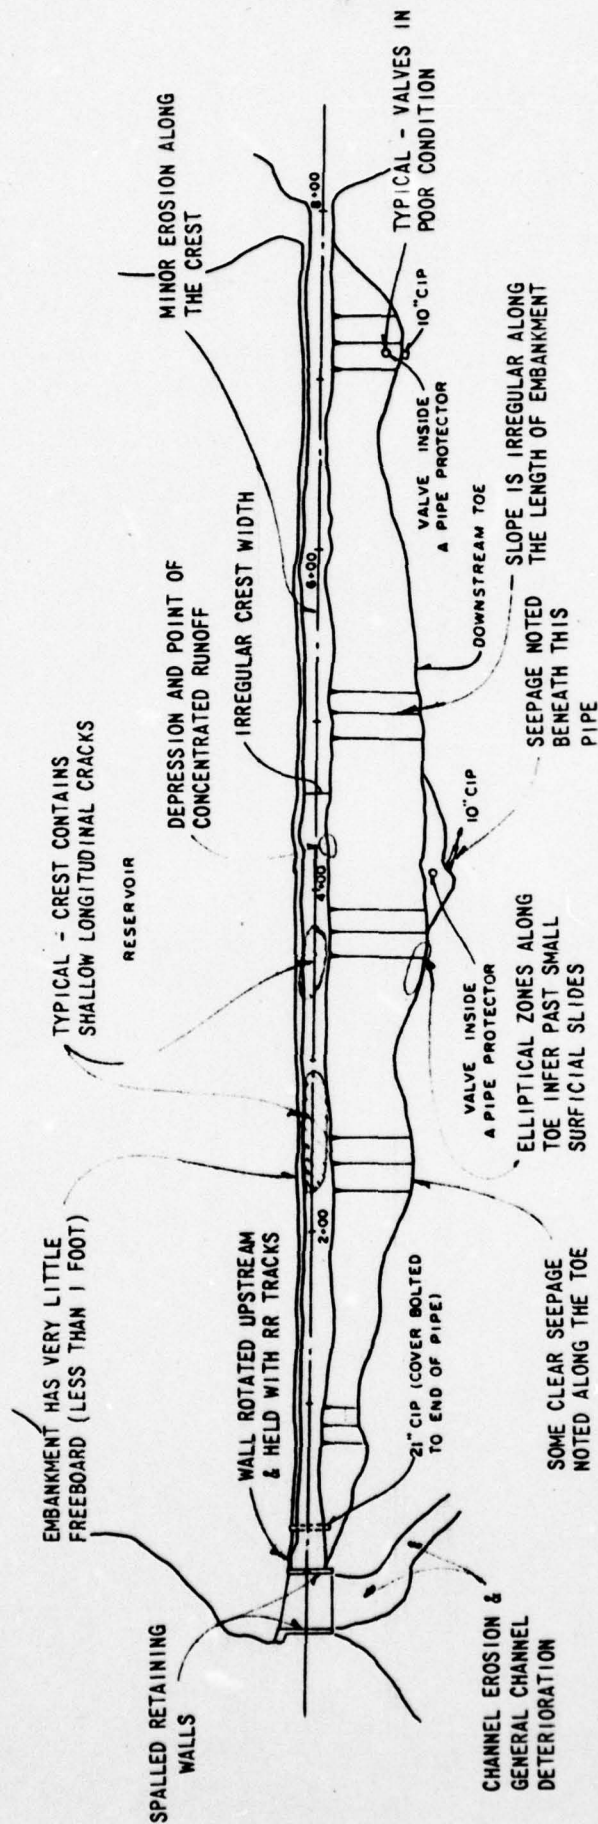
FIELD OBSERVATION PLAN
POLE RUN DAM NO. 4

VISUAL EXAMINATION OF	OBSERVATIONS	REMARKS OR RECOMMENDATIONS
SURFACE CRACKS	<p>Yes. Horizontal surface cracks were noted mostly on the upstream side of the crest as shown on Sheet 5a, and in Appendix D. They appear to be surface cracks and there was no evidence found of embankment movement associated with these cracks.</p>	
UNUSUAL MOVEMENT OR CRACKING AT OR BEYOND THE TOE	<p>None observed but several small elliptical areas along the downstream toe were observed which appear to be scars of old shallow surface slides.</p>	
SLOUGHING OR EROSION OF EMBANKMENT AND ABUTMENT SLOPES	<p>Minor erosion was noted along the crest and at a few locations along the slope. One depressed area as shown on Sheet 5a, appears to be a place where surface runoff concentrates before passing over the downstream slope.</p>	
VERTICAL AND HORIZONTAL ALIGNMENT OF THE CREST	<p>Horizontal alignment appears to be good with no significant deviation when compared to old photographs. The vertical alignment undulates as shown on Plate 4, Appendix E.</p>
